**Walama Restoration Project**  
*Community Supported Rehabilitation  
And Native Re-vegetation of our Watersheds*  
PO Box 894  
Eugene, OR 97440  
541.484.3939  
[info@walamarestoration.org](mailto:info@walamarestoration.org)  
[www.walamarestoration.org](http://www.walamarestoration.org)

## Riparian Restoration Plan for the Quiet Waters Homeowners Association Reach of the Yachats River

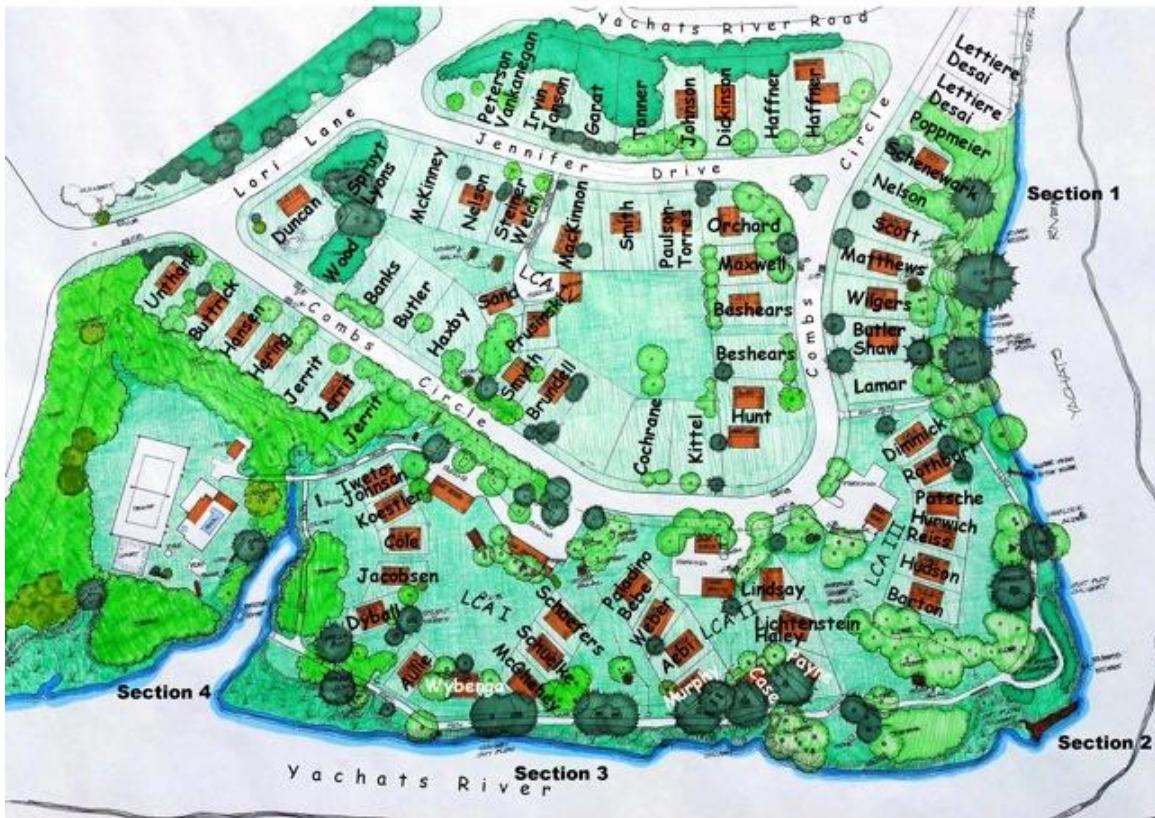
### Site Overview

The area detailed in this plan spans the north bank of the Yachats River for the entire property owned and stewarded by the Quiet Waters Homeowners Association (QWHA). The current state of this riparian area varies from fairly healthy to insufficient in terms of vegetative cover. Tidal influences combined with regular river flow are contributing towards erosive effects notable mostly in areas without

sufficient vegetation. The continued erosion of this reach presents considerable risk to the aesthetics, riparian habitat value and property interests of QWHA. There are multiple species of invasive vegetation on site. Current populations are manageable though if left unchecked could eventually threaten the health and function of the riparian area.

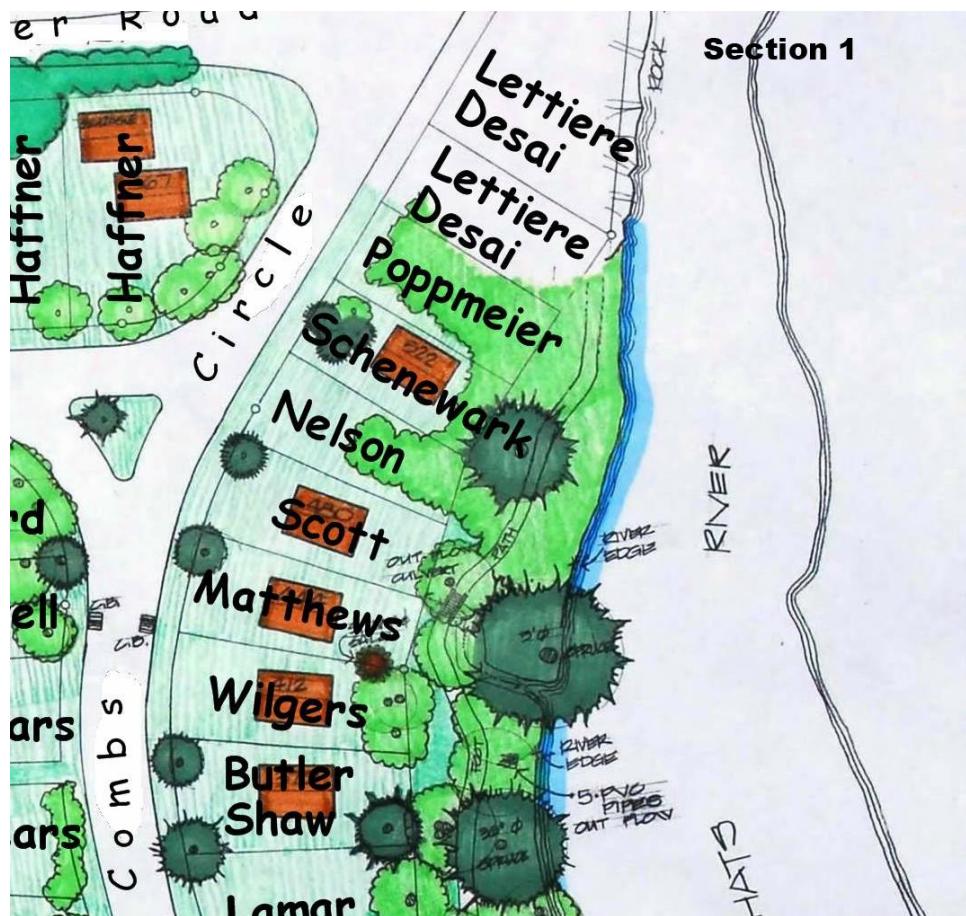
### **Restoration Strategy Section 1**

Scattered vegetative cover in this area merits more riparian plantings. Scattered populations of Reed Canary Grass (*Phalaris arundinacea*) occupy the upstream portion of this section. Small patches of English Ivy (*Hedera helix*) should be removed by hand to prevent further infestation. Geo-textile fabric should be placed to shade out populations of Reed Canary Grass. The fabric is held in place by wooden stakes and removed after two growing seasons. Native shrubs should be planted and native grass seed sown following removal of shading material. The majority of planting should occur in the downstream portions of section one. This section of the reach currently has little to no woody vegetation. The river is currently undermining the banks of the downstream portion of section one. Willow fascines should be placed along the stream bank to help stabilize the bank, provide vegetative cover and improve habitat value. Willow fascines are bundles of live cuttings tied together resembling a sausage or burrito and placed into shallow trenches dug into the stream-bank. Fascines may range between 4- 12' in length and 8-24" in diameter. Bundles should be secured with twine or other

cordage every 12-18". Fascines will sprout forming a dense matrix of roots to help stabilize the banks of the river. Sprouted fascines help contribute to water quality by taking up salts and nutrients and reducing sedimentation. In addition to fascines, willow cuttings should be liberally staked along this reach of riverbank including placed strategically as staking material for installed fascines. Willow stakes should be 3- 6' in length and at least 3/8" diameter at the butt end. Biodegradable jute netting should be placed to further secure biological bank stabilization efforts and to help reduce sedimentation. See the QWHA re-vegetation plan for a complete breakdown of species and quantities to plant for section one.

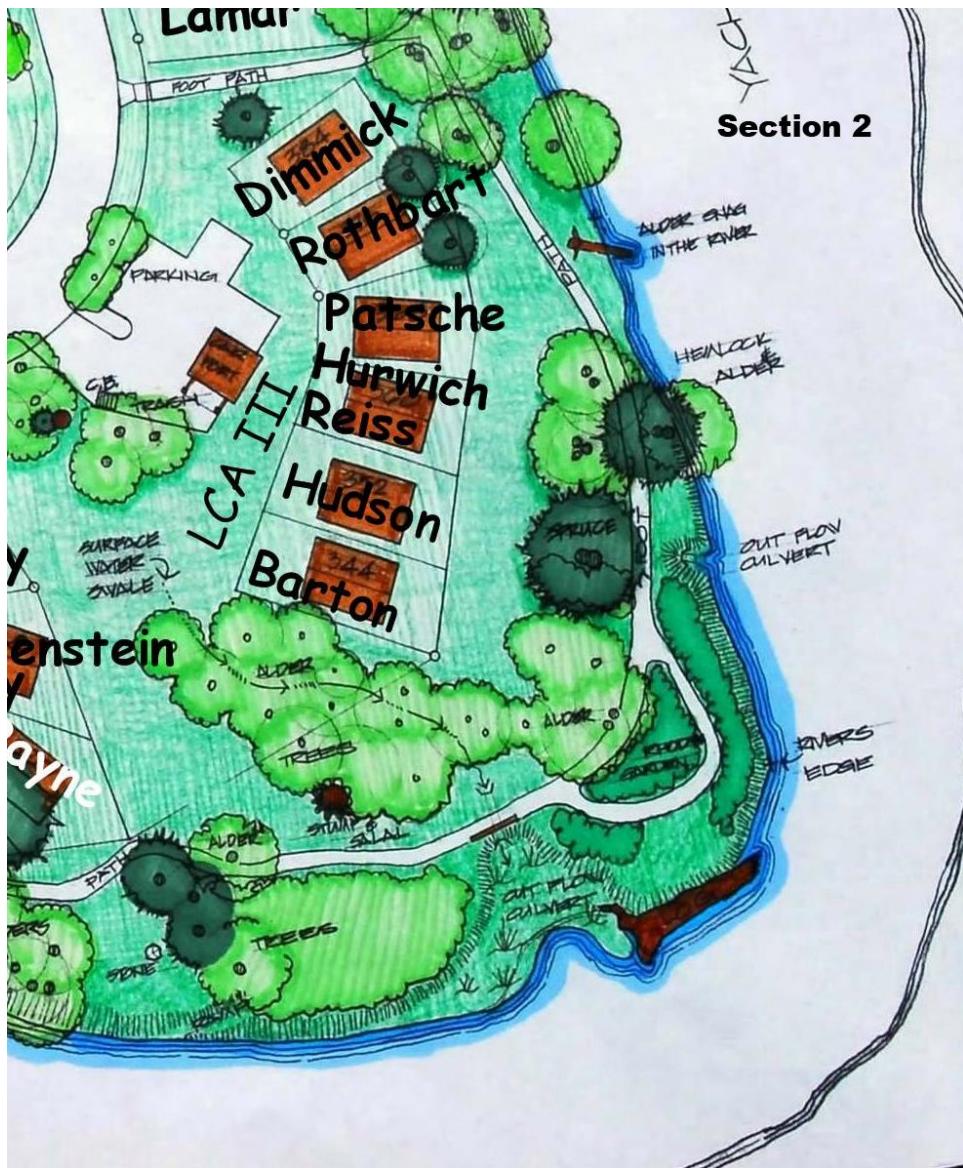
## **Restoration Strategy Section 2**

Bank stabilization and erosion control constitute the majority of rehabilitation efforts in section two. Portions of this section with a healthy amount of vegetative cover will help to serve as a model for on site re-vegetation efforts. Small patches of English ivy (*Hedera helix*) should be removed by hand to prevent further site infestation. The area currently being severely undermined with a large sand bar adjacent to the river contains the highest priority for section two. This area is currently being undermined along the stream and just under the handrail adjacent to the footpath. The top edges of the slope in this area should be profiled to create a more gradual slope. Profiling entails contouring the slope so that there is a more gradual decline as opposed to a steep drop off of the bank. Profiling should occur where little to no vegetation would be impacted on the top of the slope. Willow fascines should be utilized following bank profiling to establish a root matrix to further stabilize the slope. Fascines would be placed towards the bottom of the slope. Biodegradable jute netting should be placed over willow fascines and covering profiled areas to assist bank stabilization and to help prevent erosion. Willow stakes should be liberally applied throughout the area to help secure fascines, prevent erosion and contribute to habitat function. A similar strategy should be employed adjacent to the river in the previous canoe launch area. Planting should occur in and along the swale leading down to the river that has had chunks of asphalt added. This area is immediately downstream from the canoe launch area. Planting of native woody vegetation should also occur on the flat above the canoe launch area, in the swale across the footpath from the handrail and just upstream from the previously mentioned undermined area that was recently scoured of vegetation from high water. Planting should also occur in the open space to the left of the footpath immediately downstream from the severely undermined area. The unmanaged trail leading to the canoe launch area should be left open to provide river views and access to QWHA residents. See the QWHA re-vegetation plan for a complete breakdown of species and quantities to plant for section two.

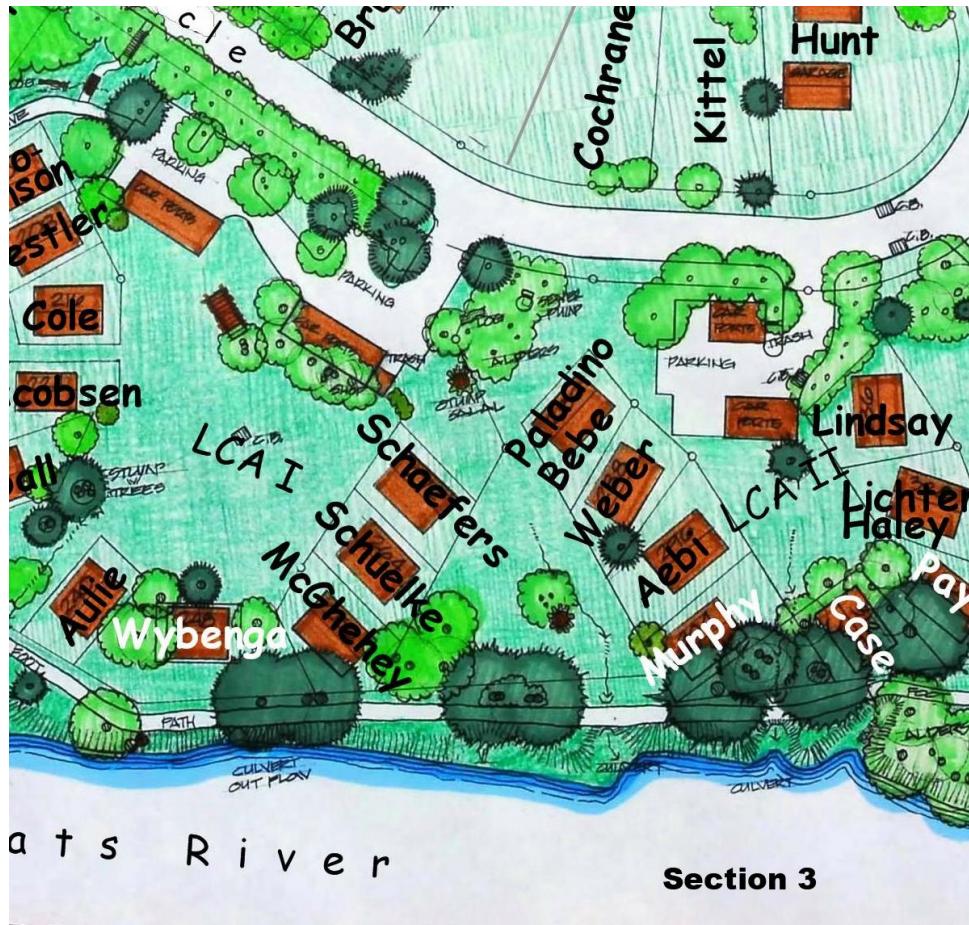
### Restoration Strategy Section 3

Limited vegetative cover and homes located in close proximity to the Yachats River create challenges in section three. Small patches of English ivy (*Hedera helix*) should be removed by hand to prevent further infestation. A small patch of Periwinkle (*Vinca minor*) should be removed to prevent further infestation. Placement of geo-textile fabric will help to facilitate this process. Following removal of the fabric, lingering roots should be hand removed. Bare soil from Vinca removal efforts should be immediately sown with native grass seed and planted with appropriate woody vegetation. Willow fascines should be employed adjacent to the riverbank to promote stabilization

efforts and improve habitat function. Jute netting and further willow staking should immediately follow the installation of fascines. Woody vegetation should be planted throughout the entirety of section three. Plantings in section three should contain sporadic breaks to allow for river viewing by QWHA residents. See the QWHA re-vegetation plan for a complete breakdown of species and quantities to plant for section three.

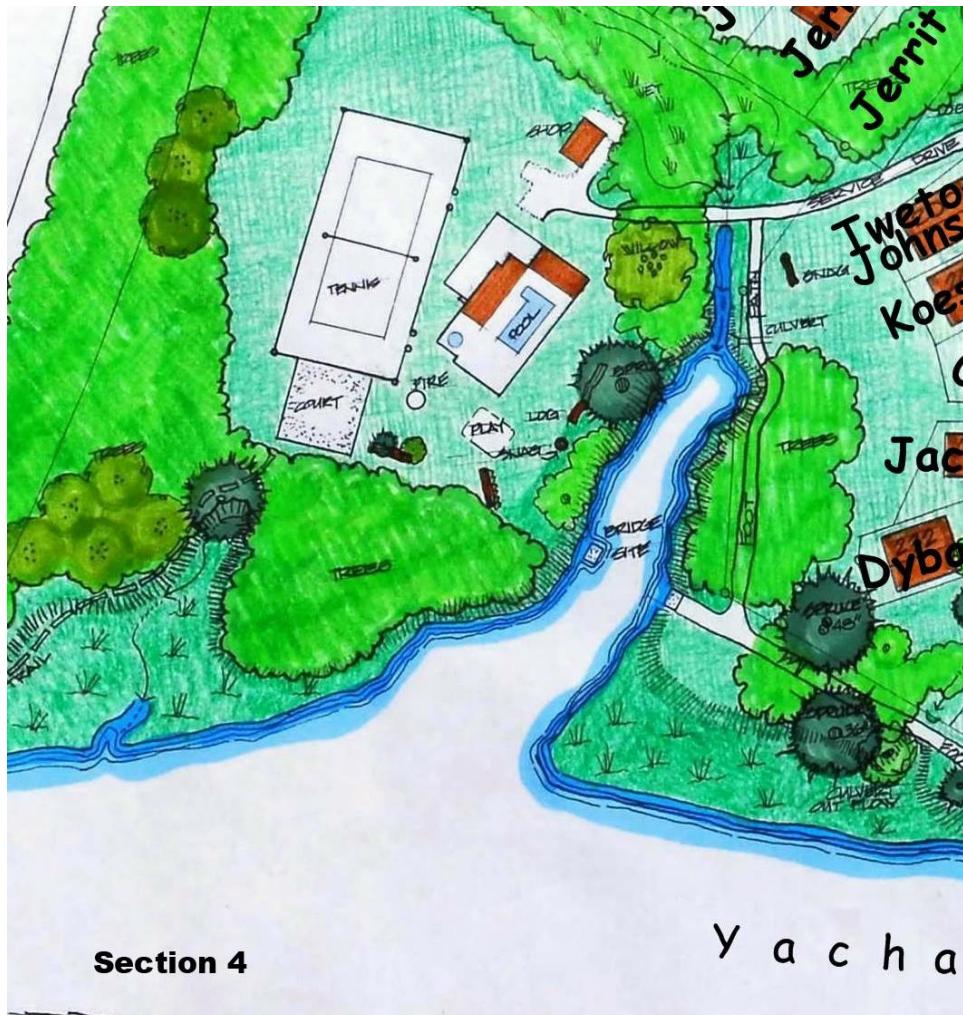
#### Restoration Strategy Section 4

Exotic vegetation, limited canopy and eroding slopes are issues to be addressed in section four. Placement of geo-textile fabric over populations of Reed Canary grass should be employed along the Yachats River on the upstream portion of where the tidal stream enters the river. The sowing of native grass and installation of appropriate woody vegetation should occur immediately following removal of the fabric. The slope adjacent to the tidal stream on the QWHA poolside is being undermined and would be enhanced from

stabilization efforts. This area requires profiling of the slope followed by a jute fabric application. Willow fascines should be employed on the lower portion of the slope. Native grass and woody vegetation should be installed to further enhance stabilization and habitat improvement efforts. Removal of exotic vegetation should occur in the wetland at the upper reaches of the tidal stream. Armenian blackberry (*Rubus armeniacus*), English ivy and Scotch broom (*Cytis scoparius*) currently occupy and threaten the long-term health of this small wetland area. Blackberries should be cut followed by the grubbing of their root crowns. Ivy should be hand removed and Scotch broom should be pulled with a weed wrench. See the QWHA re-vegetation plan for a complete breakdown of species and quantities to plant for section four.
